Rehabilitation Methodologies of Established Building to Embrace Repair Techniques

P. UmaSaikrishna¹, D. Pavan Kumar², N. Sudeep Vinay³, E. Vaishnavi⁴,
M. Mukesh⁵

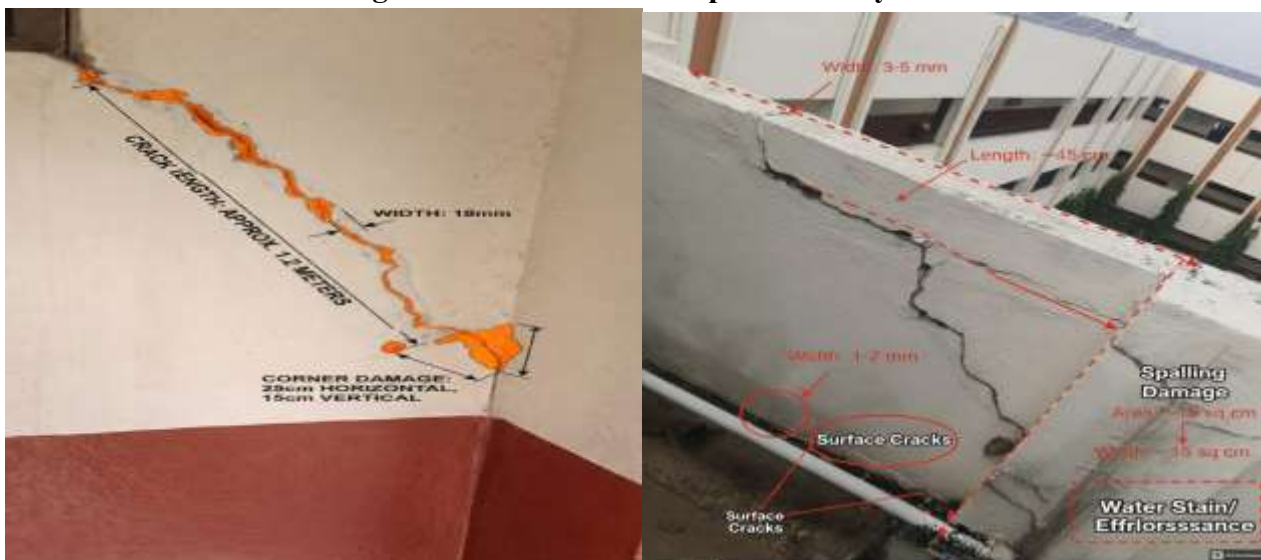
Figure 2: Visual Crack Inspection analysis

Detailed visual inspection and crack mapping revealed significant structural and durability-related distress within the building. A major diagonal crack measuring approximately 1.2 m in length with a maximum width of 18 mm was observed at the interior corner, accompanied by localized spalling (25 cm × 15 cm), indicating severe structural movement likely due to differential settlement or stress concentration at the re-entrant corner. In the parapet wall, a 45 cm horizontal crack (3–5 mm wide) and vertical cracks (1–2 mm) were recorded, suggesting thermal and shrinkage effects. Associated spalling, water staining, and efflorescence confirm active moisture ingress and progressive durability deterioration.

Location	Distress Type	Dimensions	Severity	Probable Cause	Recommended Action
Interior corner junction	Diagonal crack	L ≈ 1.2 m; W ≈ 18 mm	Severe	Differential settlement / structural movement	Structural evaluation; epoxy injection; crack stitching
Interior corner	Spalling	25 cm × 15 cm	Moderate–Severe	Stress concentration; loss of bond	Remove loose material; polymer-modified repair mortar

Location	Distress Type	Dimensions	Severity	Probable Cause	Recommended Action
Interior corner junction	Diagonal crack	L ≈ 1.2 m; W ≈ 18 mm	Severe	Differential settlement / structural movement	Structural evaluation; epoxy injection; crack stitching
Parapet wall (top)	Horizontal crack	L ≈ 45 cm; W 3–5 mm	Moderate	Thermal/shrinkage movement	Crack sealing; waterproofing
Parapet wall (face)	Vertical crack	W 1–2 mm	Minor–Moderate	Shrinkage strain	Surface crack filler; monitor
Parapet wall	Efflorescence & spalling	~15 sq.cm	Durability concern	Moisture ingress	Patch repair; improve drainage & waterproofing

- The major diagonal crack at the re-entrant interior corner indicates localized structural movement, likely due to differential settlement and stress concentration. Parapet wall cracks, efflorescence, and spalling further demonstrate the effects of thermal movement, shrinkage, and prolonged moisture ingress.

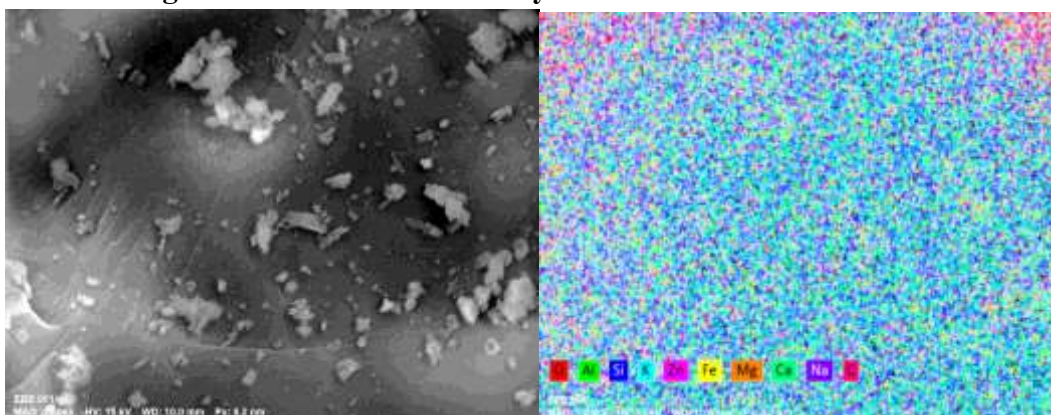
Figure 3: SEM and EDS analysis of Deteriorated Concrete

The SEM micrograph obtained at 15.0 kx magnification reveals a heterogeneous yet relatively dense cementitious matrix characterized by irregularly shaped hydration products and dispersed unreacted particles. Flaky and agglomerated formations are observed within the binder phase, indicating the development of calcium–silicate–hydrate (C–S–H) gel alongside partially reacted mineral constituents. The presence of microvoids and fine discontinuities suggests localized porosity, which may influence permeability and long-term durability. Minor microcracks visible within the matrix are likely associated with shrinkage stresses or interfacial incompatibility between hydration products and residual particles. The corresponding EDS elemental mapping confirms the dominance of O, Si, Al, and Ca, supporting the formation of calcium aluminosilicate hydration phases. Uniform elemental distribution indicates adequate mixing and chemical integration, while trace amounts of Fe, Mg, Na, and Zn suggest minor impurities or supplementary material contributions. Overall, the microstructural features demonstrate a reasonably compact matrix with limited defects, though localized porosity may marginally affect mechanical and durability performance.

- SEM and EDS analysis revealed a relatively dense cementitious matrix with normal hydration products (C–S–H and aluminosilicate phases), indicating that the inherent material quality remains reasonably stable. However, localized porosity and microcracking suggest progressive durability concerns, primarily influenced by environmental exposure and moisture penetration rather than fundamental material failure.

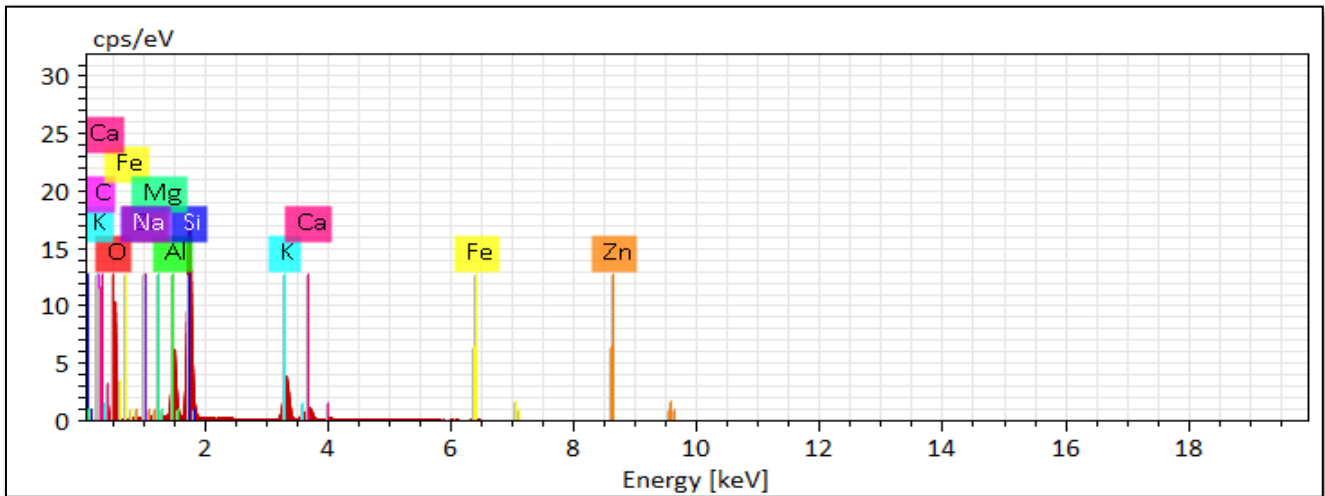
Figure 4: chemical Composition of deteriorated Concrete EDS Graph

The EDS Graph represents the presence of calcium-rich hydration products such as C–S–H and possibly $\text{Ca}(\text{OH})_2$. The Si and Al peaks indicate the formation of aluminosilicate gel phases. Minor Mg, Na, and K peaks suggest alkali and supplementary mineral constituents, while Fe signals likely arise from trace impurities. The distinct Zn peak reflects zinc-bearing compounds, possibly from admixtures or contamination. Overall, the spectrum shows uniform elemental distribution without abnormal high-intensity peaks, indicating chemical stability within the analyzed region.
