# Influence of FRP Strengthening on Structural Performance of Shear Deficient RC Beams with Varying Degree of Corrosion

<sup>1,2,3</sup>Student, Department of Civil Engineering, Toc H College of Engineering Arakkunnam

<sup>4</sup>Assistant Professor, Department of Civil Engineering, Toc H College of Engineering Arakkunnam,

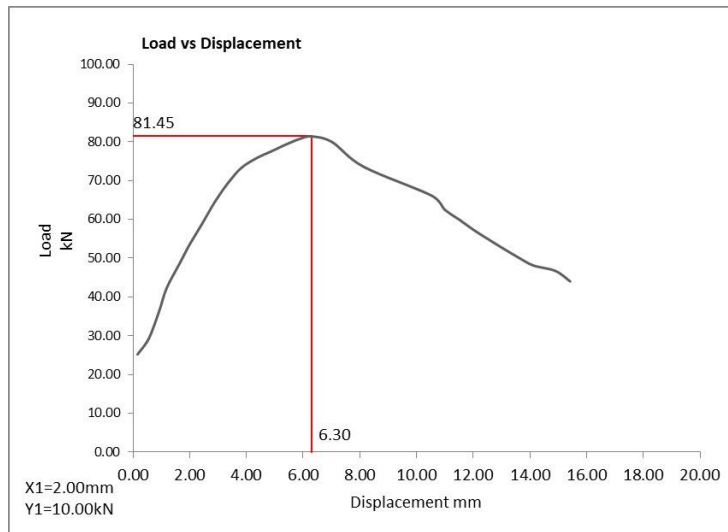
**Figure 2: Load displacement graph of Ultimate load test**

After 28 days of curing, the eight beams were subjected to three-point bending test with an effective span of 800 mm and pre-loaded to 48.87 kN. The maximum pre-load was equivalent to 60% of the theoretical yielding load, representing a reasonable load level in serviceability limit state. The pre-loading induced pre-cracks to provoke pitting corrosion in the subsequent accelerated corrosion period.

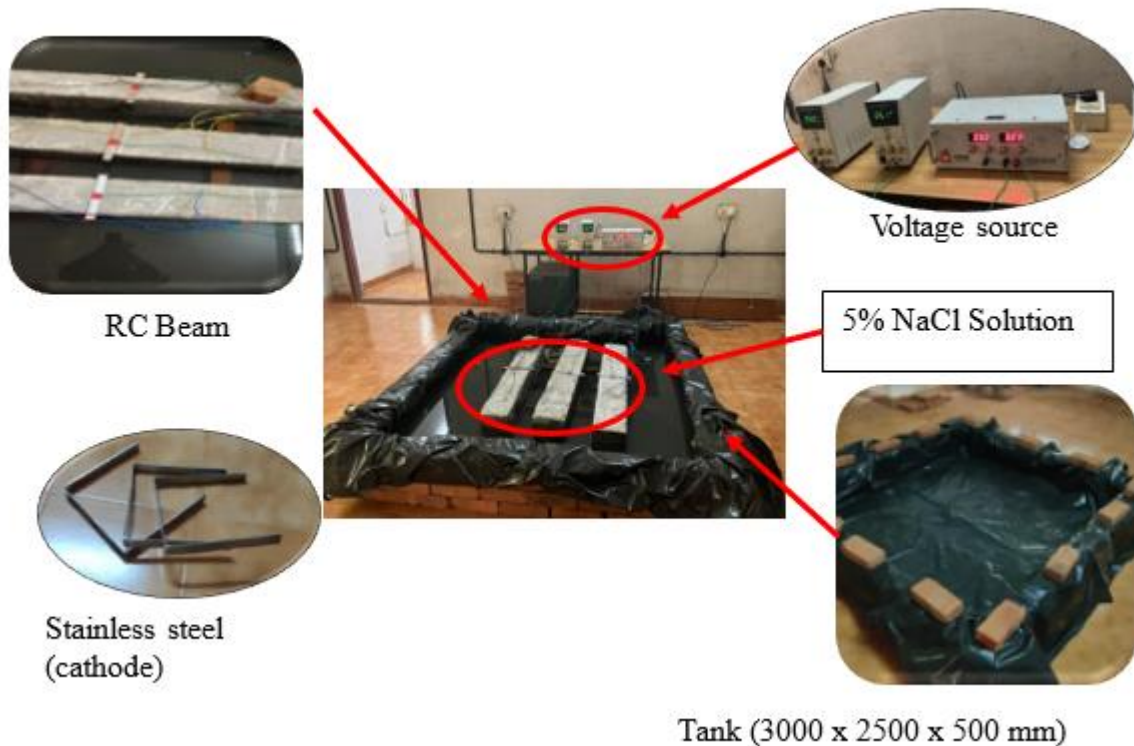
Figure.4: Experimental setup

The specimens and stainless-steel plate were connected in parallel to the power supply. As shown in Figure.4, specimen were placed in a brick made tank with size of 3000 mm long, 2500 mm wide and 500 mm height which contained salted water (5% of salt). The corrosion current was monitored daily, and any drift was corrected.
