Socio-Economic Vulnerability and Recovery After Cyclone Yaas: A Micro-Level Study on Coastal Communities of Purba Medinipur

Mintu Jana¹, Taniya Roy², Dr. Dipak Bisai³

Abstract

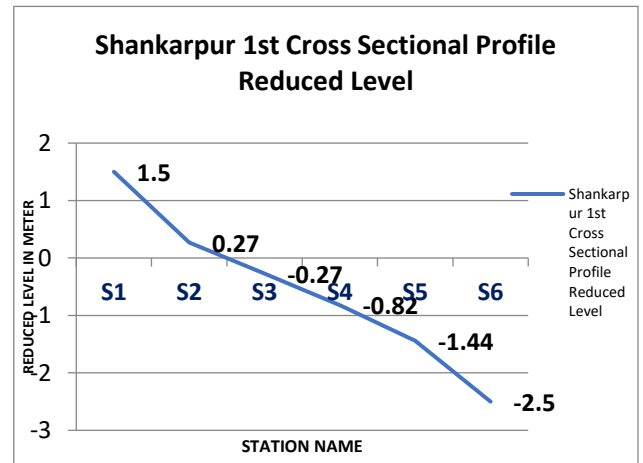
Station	Reduced Level
S1	1.5
S2	0.27
S3	-0.27
S4	-0.82
S5	-1.44
S6	-2.5

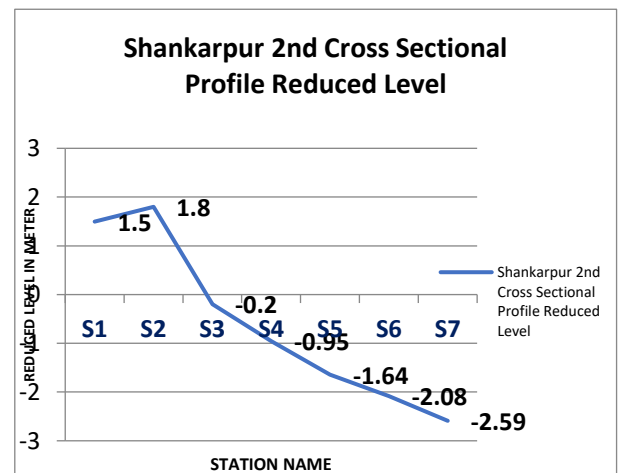
Shankarpur 2nd Cross Sectional Profile

Station	Reduced Level
S1	1.5
S2	1.8
S3	-0.2
S4	-0.95
S5	-1.64
S6	-2.08
S7	-2.59

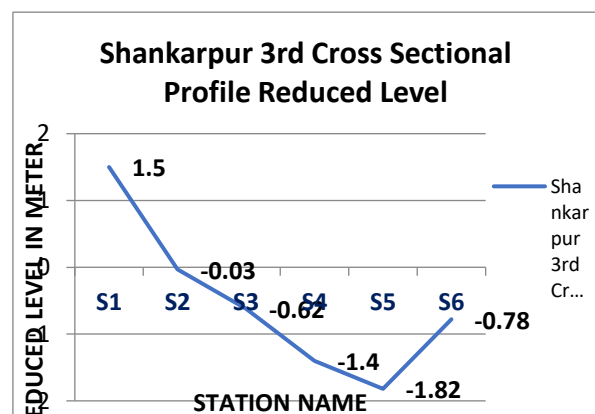
Shankarpur 3rd Cross Sectional Profile

Station	Reduced Level
S1	1.5
S2	-0.03
S3	-0.62
S4	-1.4
S5	-1.82
S6	-0.78

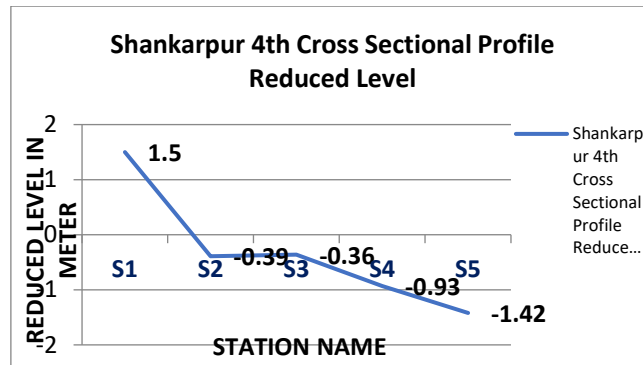
Shankarpur 4th Cross Sectional Profile

Station	Reduced Level
S1	1.5
S2	-0.39
S3	-0.36
S4	-0.93
S5	-1.42

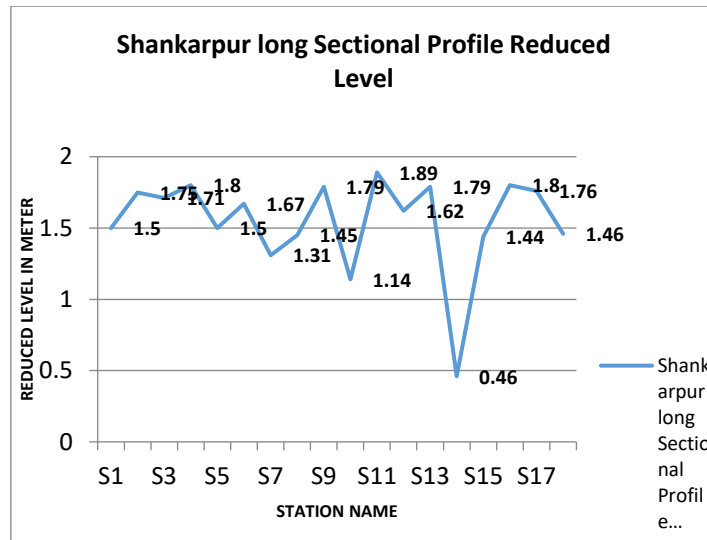
Station	Reduced Level
S1	1.5
S2	1.75
S3	1.71
S4	1.8
S5	1.5
S6	1.67
S7	1.31
S8	1.45
S9	1.79
S10	1.14
S11	1.89
S12	1.62
S13	1.79
S14	0.46
S15	1.44
S16	1.8
S17	1.76
S18	1.46

In our study area , we find out that Shankarpur coast has plane in our eye estimation but we try to find out the slope character in different beach . So we select the 18 station along the shore line and collect the data by the dumpy level . And each station is select equidistant along the beach . Above the long profile we see that sankarpur coast has irregular slope along the shore line but some of the station are show steep slope .

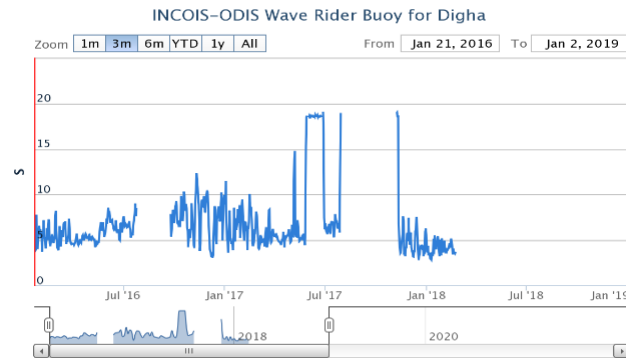
Wave Height

Wave Height, Wave Peak Direction and Wave Mean Period of Digha Subarnarekha Coastal Tract
