# Five-Rooted Maxillary Third Molar Encountered During Routine Extraction: A Rare Anatomical Variation with Surgical Implications

Ms. S Sri Lokeshwari<sup>1</sup>, Dr. S Darshan Kumar<sup>2</sup>

<sup>1</sup>CRRI, Vinayaka Missions Sankarachariyar Dental College

<sup>2</sup>3rd Year Post Graduate, Department of Oral and Maxillofacial Surgery, Vinayaka Missions  
Sankarachariyar Dental College

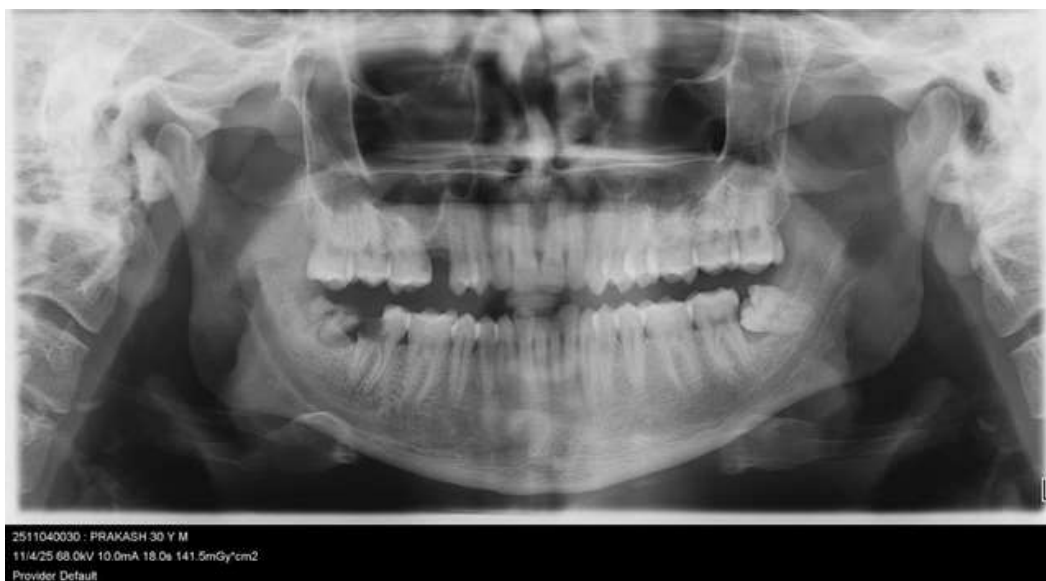
Figure 1. Preoperative Panoramic Radiograph Demonstrating the Mandibular Left Third Molar Requiring Surgical Extraction and the Opposing Maxillary Left Third Molar. No Obvious Accessory Root Morphology Is Evident on the Panoramic Image.

developed divergent roots, explaining the unusual intraoperative resistance. Retrospective evaluation of the panoramic radiograph confirmed that the accessory roots had been obscured by image superimposition. The socket was irrigated and closed with 3-0 black silk sutures. Healing was uneventful, and the patient remained asymptomatic at one-week follow-up.

This case also highlights the limitations of panoramic radiography in detecting accessory roots. Superimposition of anatomical structures may mask complex root morphology, leading to underestimation of extraction difficulty [4, 6]. Although CBCT is not routinely indicated for every third molar extraction, three-dimensional imaging may be considered when conventional radiographs are inconclusive or when clinical findings do not correspond with the radiographic appearance [6].

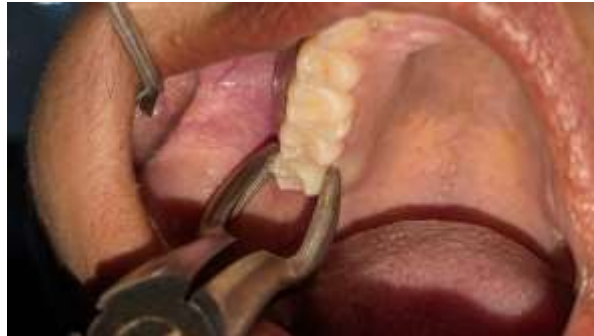
**Figure 2. Clinical View During Surgical Extraction of the Maxillary Third Molar.**

After obtaining written informed consent, the mandibular third molar was surgically removed without complications. Attention was then directed to the maxillary third molar. Local anaesthesia was administered using posterior superior alveolar and greater palatine nerve blocks, followed by reflection of a conservative full-thickness mucoperiosteal flap to improve access. Initial luxation was performed using straight and curved Warwick James elevators. Despite adequate access and a favourable radiographic appearance, the tooth demonstrated marked resistance with minimal mobility.

The unexpected resistance suggested the presence of complex root anatomy. Excessive force and aggressive instrumentation were deliberately avoided to reduce the risk of root fracture, maxillary tuberosity fracture, oroantral communication, or displacement of the tooth into adjacent anatomical spaces. Progressive luxation was continued using controlled buccopalatal and rotational movements with maxillary third molar forceps while supporting the surrounding alveolar bone. After approximately 20 minutes, the tooth was delivered atraumatically.

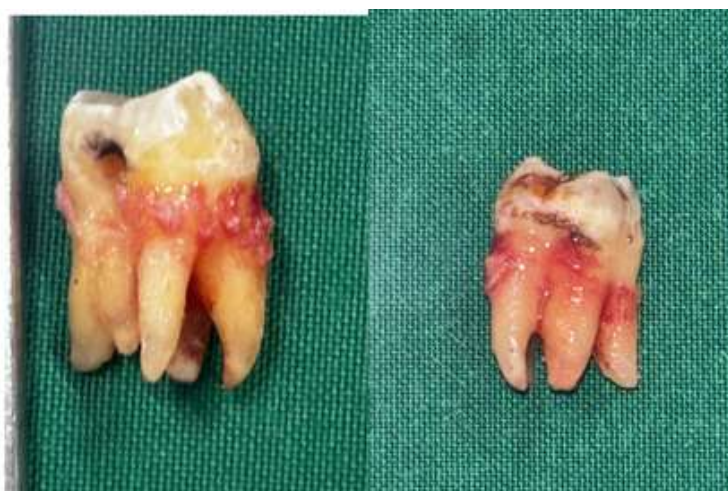
**Figure 4. Mesial and Distal Aspects of the Extracted Tooth Illustrating the Divergent Accessory Roots.**

The extraction socket showed no evidence of oroantral communication, excessive bleeding, or injury to surrounding tissues. Examination of the extracted tooth revealed five completely separated, well-

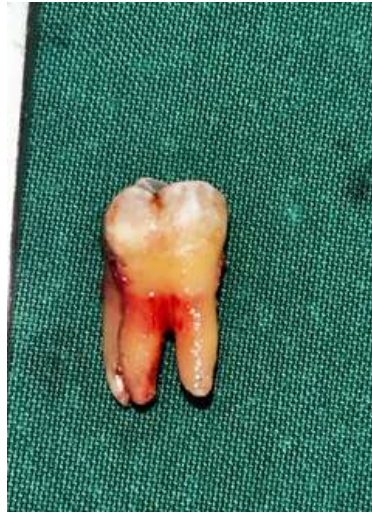
**Figure 5. Palatal Aspect of the Extracted Tooth Demonstrating Root Morphology From an Alternative Perspective.**

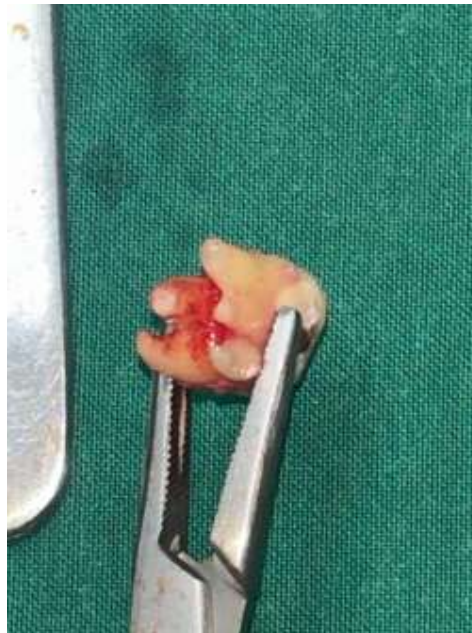
**Figure 6. Apical View Highlighting the Spatial Arrangement of the Five Independent Roots.**
