# Heritage Sites and Climate Resilience: Selected Case Studies of Buddhist Archaeological Sites of Telangana

V. Vamshidhar<sup>1</sup>, Prof. Dr. Kavita Daryani Rao<sup>2</sup>

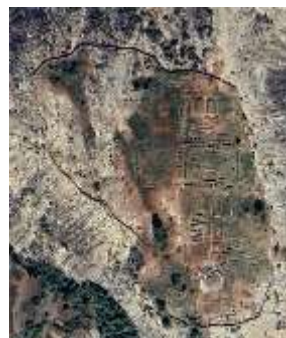
Figure 1: Ariel view of Phanigiri Buddhist site,  
( Source: Google Earth, 2024)

The topographical context of the site also played a crucial role in ensuring structural stability. The monuments were constructed on naturally elevated rock surfaces of the hill, providing a firm foundation capable of supporting masonry loads. Terraced construction across the hill slopes created stable platforms contributing to slope stabilization. The circular plan of the stupa further enhanced structural stability by allowing uniform distribution of loads along the circumference of the structure. The elevated hilltop location promotes natural ventilation and reduces moisture accumulation around the foundations. The sloping terrain facilitates effective surface drainage during monsoon seasons, thereby minimizing water infiltration into masonry joints.

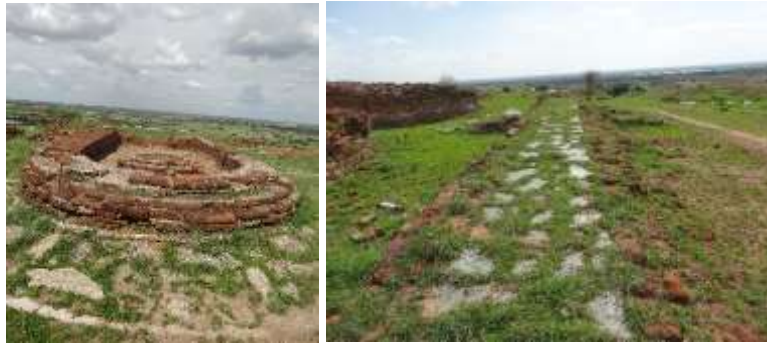
Figure 2: Remains of Buddhist site on Phanigiri

The archeologically remains at the Phanigiri Buddhist Site demonstrate a significant degree of structural stability and environmental adaptability, reflecting the construction knowledge and planning strategies employed in early Buddhist architecture. Located in the Deccan plateau region of Telangana, the site primarily dates to 2<sup>nd</sup> c. BCE – 3<sup>rd</sup> c. CE. Locally available limestone was used for its durability and compressive strength. Rubble masonry techniques wherein irregular stone blocks were arranged in thick load-bearing walls with smaller stones filling the interstitial gaps were adopted. In addition to stone masonry, burnt bricks often larger than modern bricks, some of them measuring 22”x11”x3”, were employed in construction of stupa, chaityas, viharas and other structural elements. They were bonded with lime mortar, which served as a flexible and durable binding material capable of accommodating minor structural movements. Thick masonry walls help moderate internal temperatures by reducing heat penetration during hot summers, while lime mortar joints allow moisture evaporation, thereby preventing long-term deterioration of masonry.

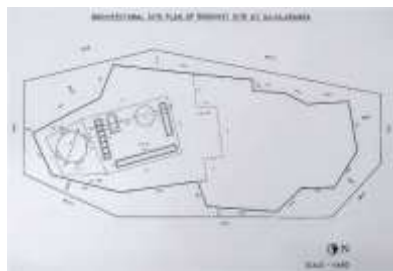
Figure 3: Plan of Buddhist site at Ganjulabanda  
( Source: Department of Heritage, Telangana )

The Gajulabanda Buddhist Site represents an important early historic Buddhist settlement in Telangana. The site which flourished during 1<sup>st</sup> c. CE- 2<sup>nd</sup> c. CE, particularly under the influence of the Satavahana Dynasty, reflects a well-planned integration of materials, construction techniques, and topographical advantages. Archaeological evidence suggests that stone masonry and burnt brick were the primary construction materials used for building stupas, viharas and other monastic structures. In structural remains, rubble masonry techniques were employed, where irregular stone blocks were assembled with smaller stones filling the voids, thereby enhancing the cohesion and mass stability. Brick masonry, often bonded with lime mortar, was also used. The topographical context of Gajulabanda, a slightly elevated

terrain or hillock, where structures were often built directly on stable rock surfaces enhanced the stability of monuments. In addition to structural considerations, the planning and construction of the site reveal adaptation to regional climatic conditions similar to the Phanigiri site. The elevated terrain facilitates natural drainage during monsoon seasons, preventing water stagnation around structural foundations.

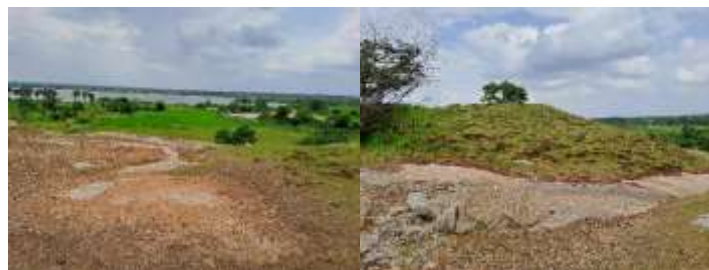
Figure 4: Stupa and surrounding environment of Gajulabanda Buddhist site, Source : Author(s), 2024 )

Like Phanigiri site, Gajulabanda Buddhist Site also illustrates a close relationship between the built environment and the natural landscape.. Located in the semi-arid plateau landscape of Telangana, it provided both environmental advantages and symbolic significance, reflecting the Buddhist preference for establishing monastic complexes in tranquil and elevated settings conducive to meditation and monastic life. The spatial organization of the site further reflects a deliberate relationship with the surrounding environment. Stupa was constructed at an elevated point, making it visually prominent within the landscape. The surrounding natural environment, including rocky outcrops, vegetation cover and Bikkeru river one of the tributaries of Godavari, to the east of the site, contributes to the overall character of the site and reinforces its integration within the broader cultural landscape. Additionally, the elevated setting allows for improved air circulation and exposure to natural light, which would have contributed to comfortable living conditions for the monastic community.

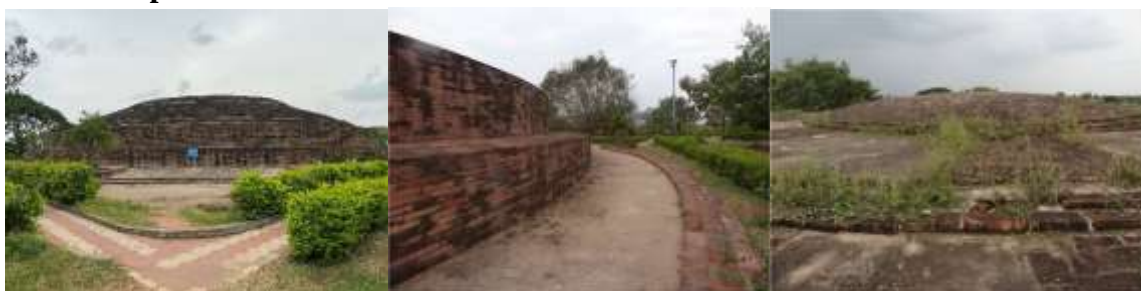
Figure 5: Stupa at Nelakondapalli Buddhist site, Source : Author(s), 2024

The Nelakondapalli Buddhist Site represents one of the most significant Buddhist archaeological sites in Telangana associated with early Buddhist monastic architecture that dates back to 1<sup>st</sup> c. BCE to 6<sup>th</sup> c. CE. The surviving structural remains demonstrate the use of durable materials, stable construction techniques, and site planning strategies that contributed to both structural stability and climatic resilience. Nelakondapalli is well known for mahastupa which is considered largest in South India. The massive construction with bricks of size 22"x11"x3" laid in systematic courses ensured structural strength. Bonding with lime mortar provided cohesion and flexibility within the masonry.

The circular drum base and hemispherical dome with recessed terraces enhanced long term stability protecting the structure from soil erosion and moisture infiltration. The region experiences high temperatures and seasonal monsoon rainfall, thick brick masonry walls provide thermal mass and the use of lime mortar allows the masonry to breathe by permitting moisture evaporation. The slightly elevated terrain of the settlement helps prevent water stagnation during monsoon seasons, while the layout of the structures allows for adequate air circulation across the complex. The integration of durable materials, effective masonry techniques, and environmentally responsive design illustrates the sophisticated construction knowledge applied in the development of this major Buddhist centre.

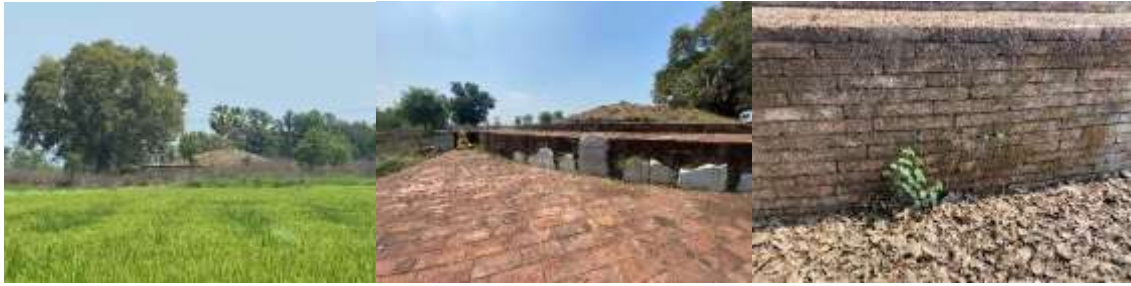
Figure 6: Stupa and surroundings at Dhulikatta Buddhist site, Source: Author(s), 2024 )

The Dhulikatta Buddhist Site represents an important early historic archaeological site in Telangana that flourished between 2<sup>nd</sup> c. BCE to 1<sup>st</sup> c. BCE. Particularly during the period of the Satavahana Dynasty, when Buddhist monastic establishments expanded across the Deccan plateau. Similar to the Nelakondapalli site, Structural stability at Dhulikatta is largely attributed to the use of robust construction materials and well-developed masonry techniques by burnt bricks and stone masonry. The bricks used were arranged in systematic courses and bonded with lime mortar. The circular plan of the stupa facilitates an even distribution of loads around the structure, reducing the concentration of stress at specific points. In addition, the embellishments in lime stone cladding to the base reflect the symbolism and iconography of Buddhist teachings.

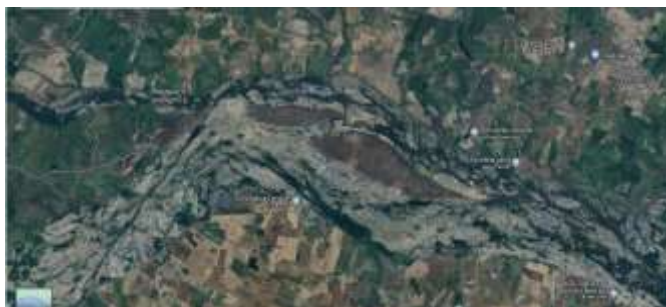
Figure 8 : Ariel view of Bavapur Kurru Buddhist site  
(Source: Google Earth, 2024)

The elevated mound setting and durable brick construction would have provided protection against seasonal flooding and moisture-related deterioration, while the island context ensured relative isolation and reduced anthropogenic pressures. Excavations and preliminary surveys revealed that the structural stability of the monuments at Bavapur Kurru is largely attributed to the use of brick masonry and carefully prepared foundation systems suited to the soft alluvial soils of the Godavari region. As it

experiences high humidity, heavy monsoon rainfall, and seasonal flooding, elevated platforms and raised plinths may have protected the structures from water accumulation and surface runoff.

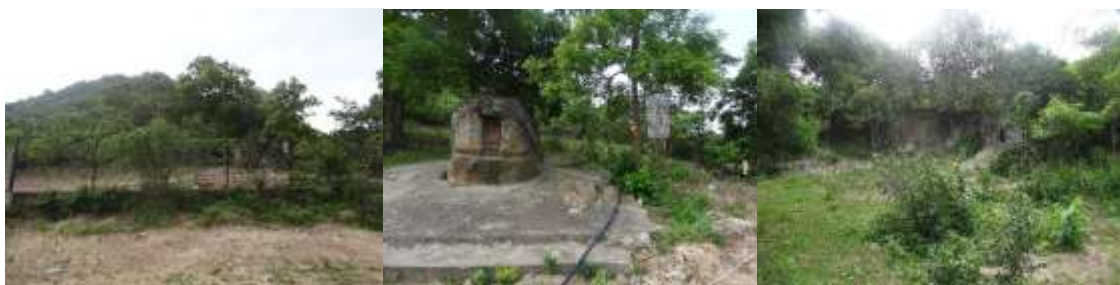
Figure 9: Hill and Buddhist Structures of Karukonda, Source: Author(s), 2024

Located within the hilly terrain of Karukonda Ramavaram in Telangana the site belongs to 3<sup>rd</sup> c. CE to 4<sup>th</sup> c. CE, experiences a tropical climate characterized by high temperatures, seasonal monsoon rainfall, and varying humidity levels. Two rock-cut caves and a rock-cut stupa are found in the footing of the hill. The caves were carved into hard, weather-resistant rock, sedimentary rock formations, primarily sandstone and lateritic formations typical of the Godavari valley region which naturally withstands

erosion, heat, and rainfall better than built structures. Rock-cut caves are carved into the hillside rather than built outward, reducing direct exposure to wind, rain, and temperature fluctuations. The natural vegetation on the hill also protected the caves and stupa from high temperatures. Despite centuries of exposure to climatic stresses such as rainfall, temperature variation, and vegetation growth, the rock cut caves survived, demonstrating considerable durability. Yet a part of the rock cut stupa is damaged because of a thunderbolt creating a crack in the boulder.
